Re: Compliance Stormwater Evaluation Inspection
Concrete Supply Co. Greer, South Carolina, Permit SCR005480

U.S. Environmental Protection Agency, Region 4
61 Forsyth Street SW, Atlanta, GA 30303
Water Compliance Inspection Report

CSC Greer ISW 2019
EPA R4 NPDES Inspection Photolog

Inspected 5/29/19

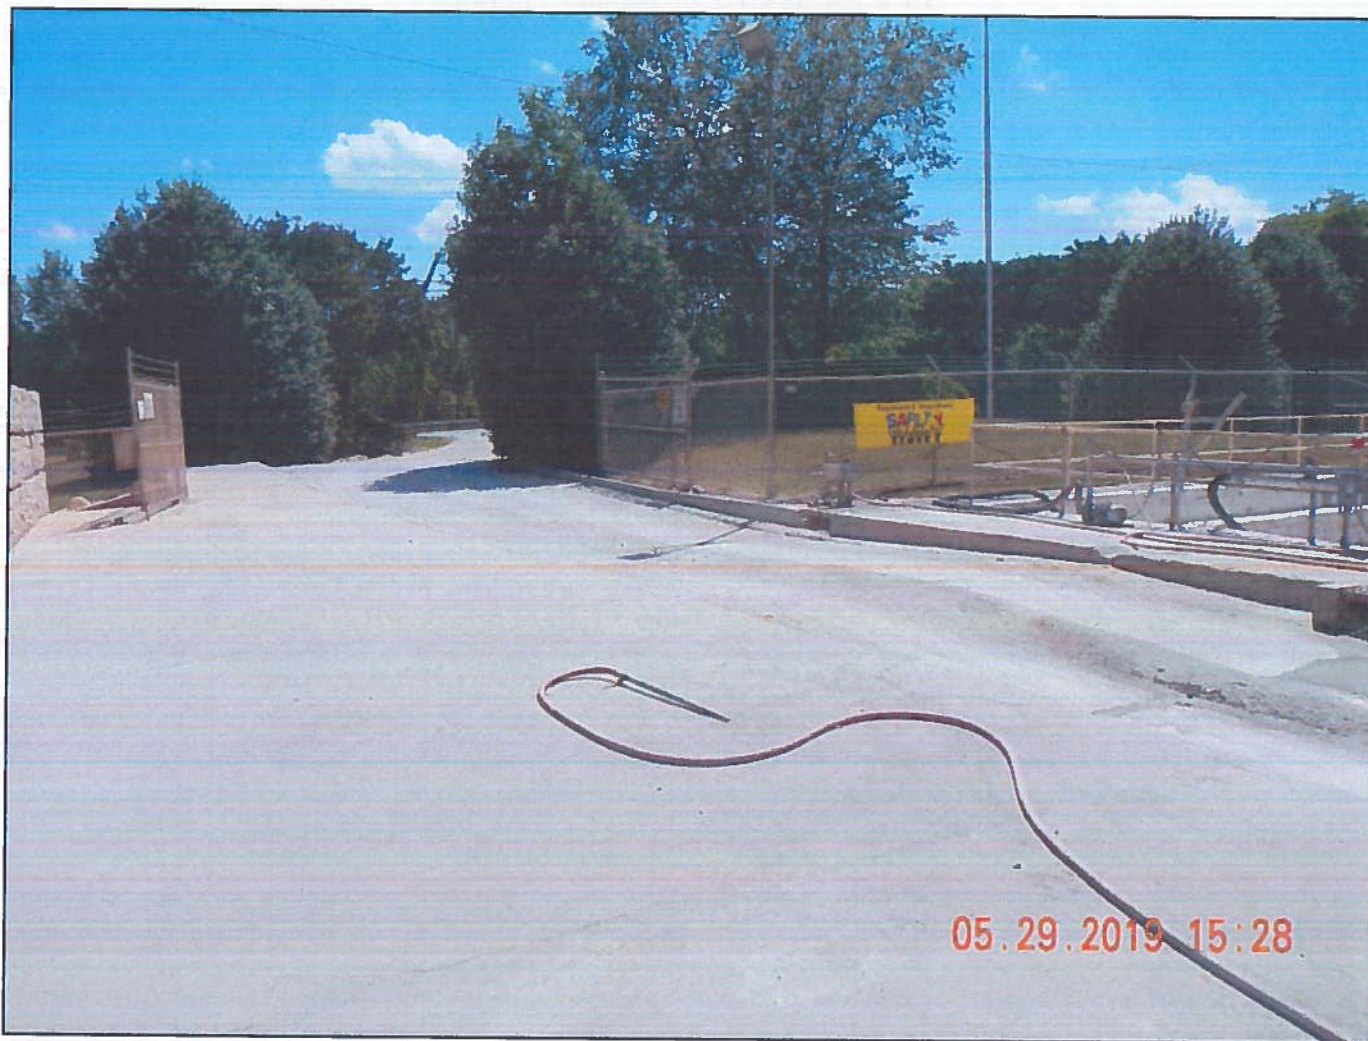
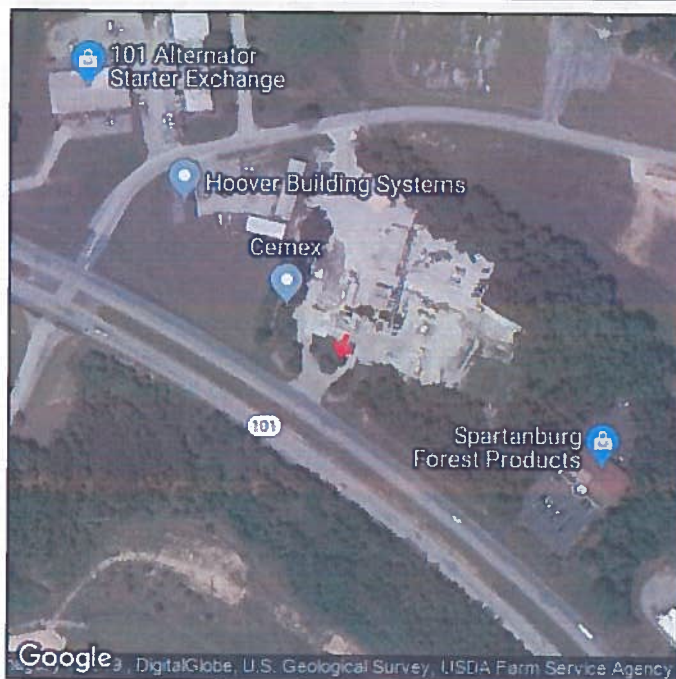
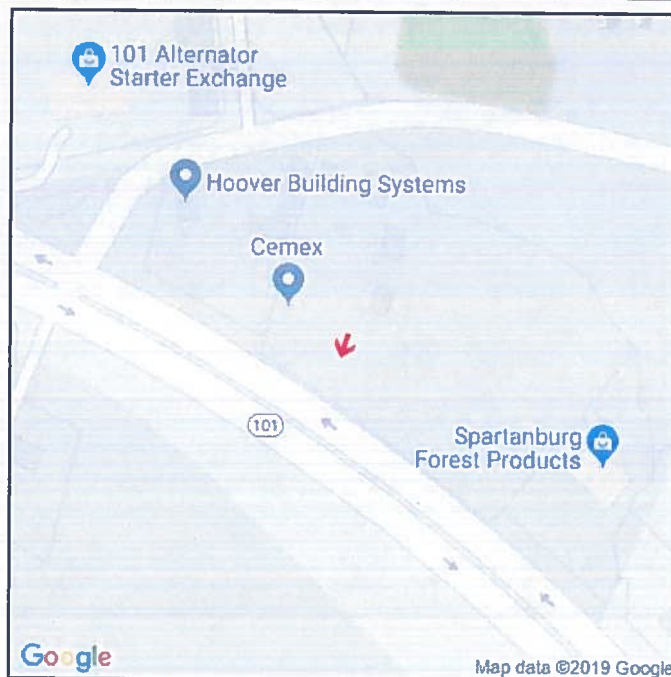
Description	Exit gate for filled trucks, out to main road (Hwy 101). To right, basins for water capture, which have pumps for reuse.
-------------	--

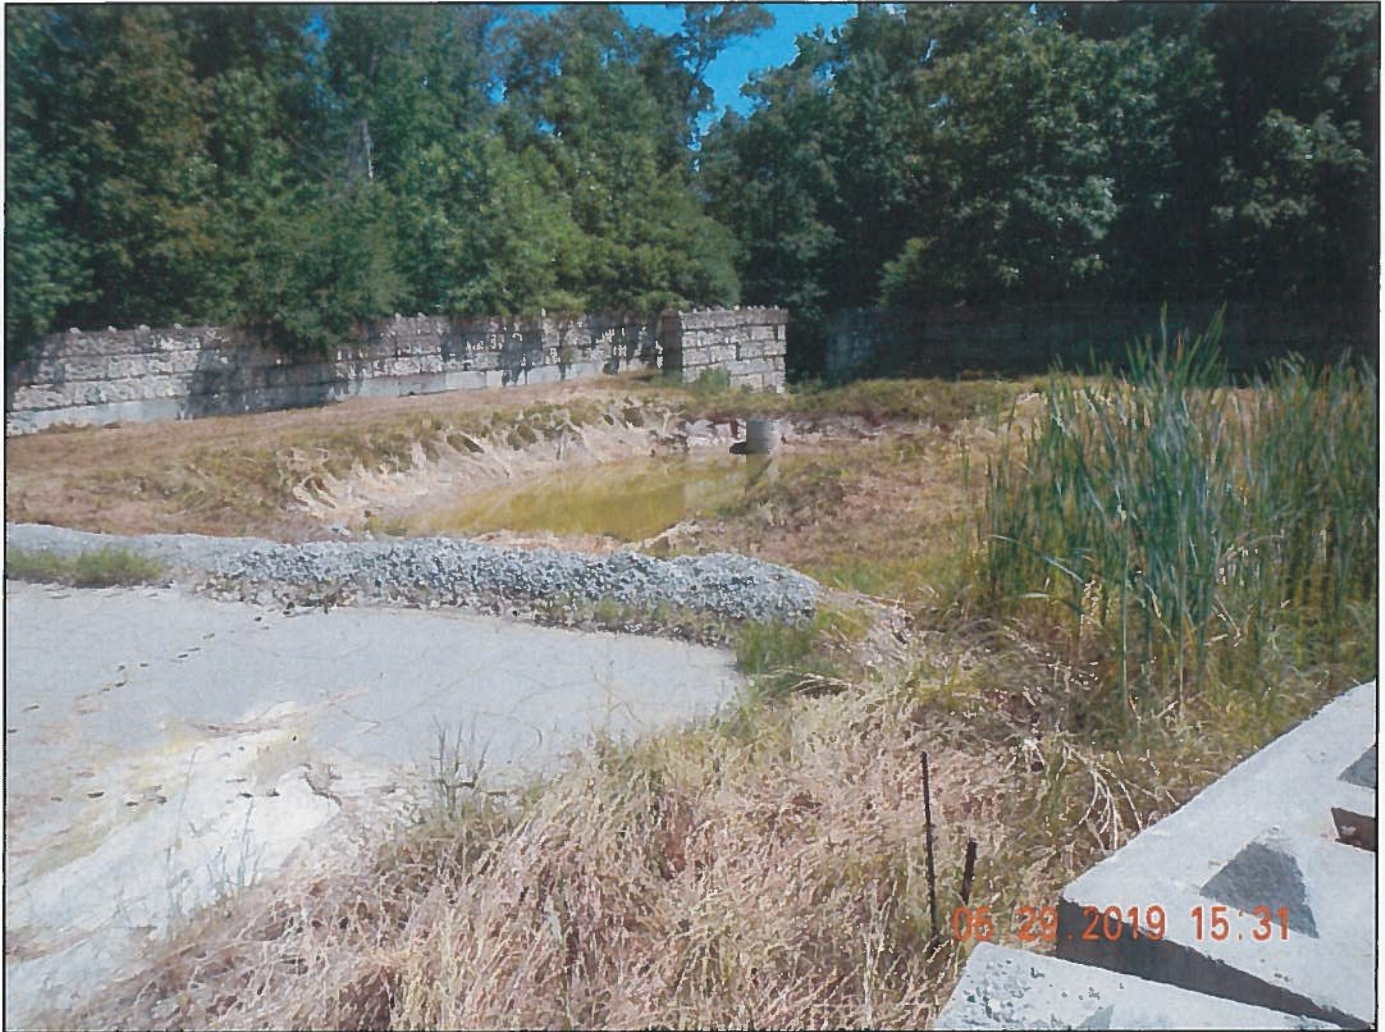
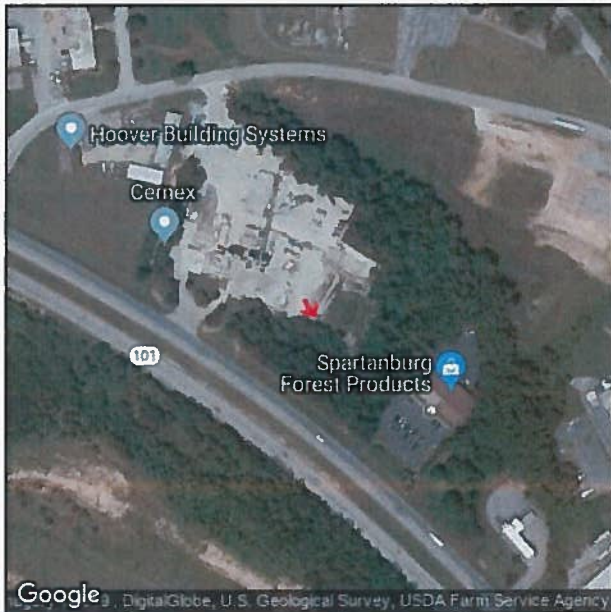
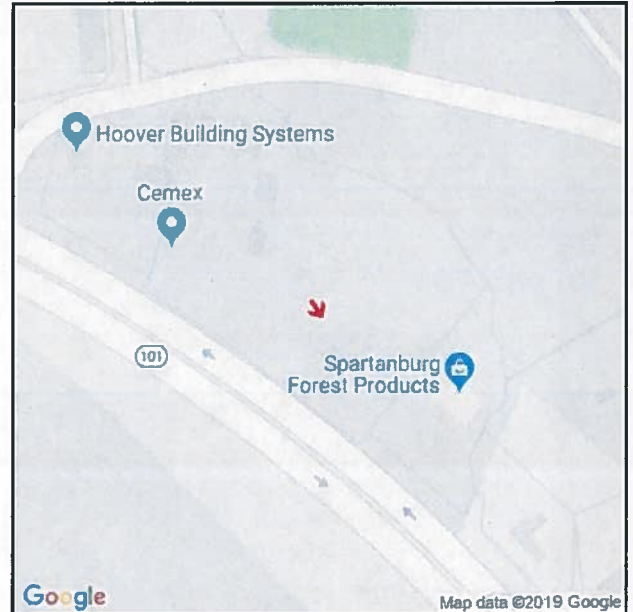
Description	The main catch basin for runoff, near the SE corner of the site. Looking southerly. Primary pond in background, with outlet structure seen in center of photo. Outlet structure comprised of zinc-steel corrugated pipe; no holes in riser; outlet pipe at bottom of riser. This pond area collects most of the runoff from the site, except for an area at the NNW corner.
-------------	---

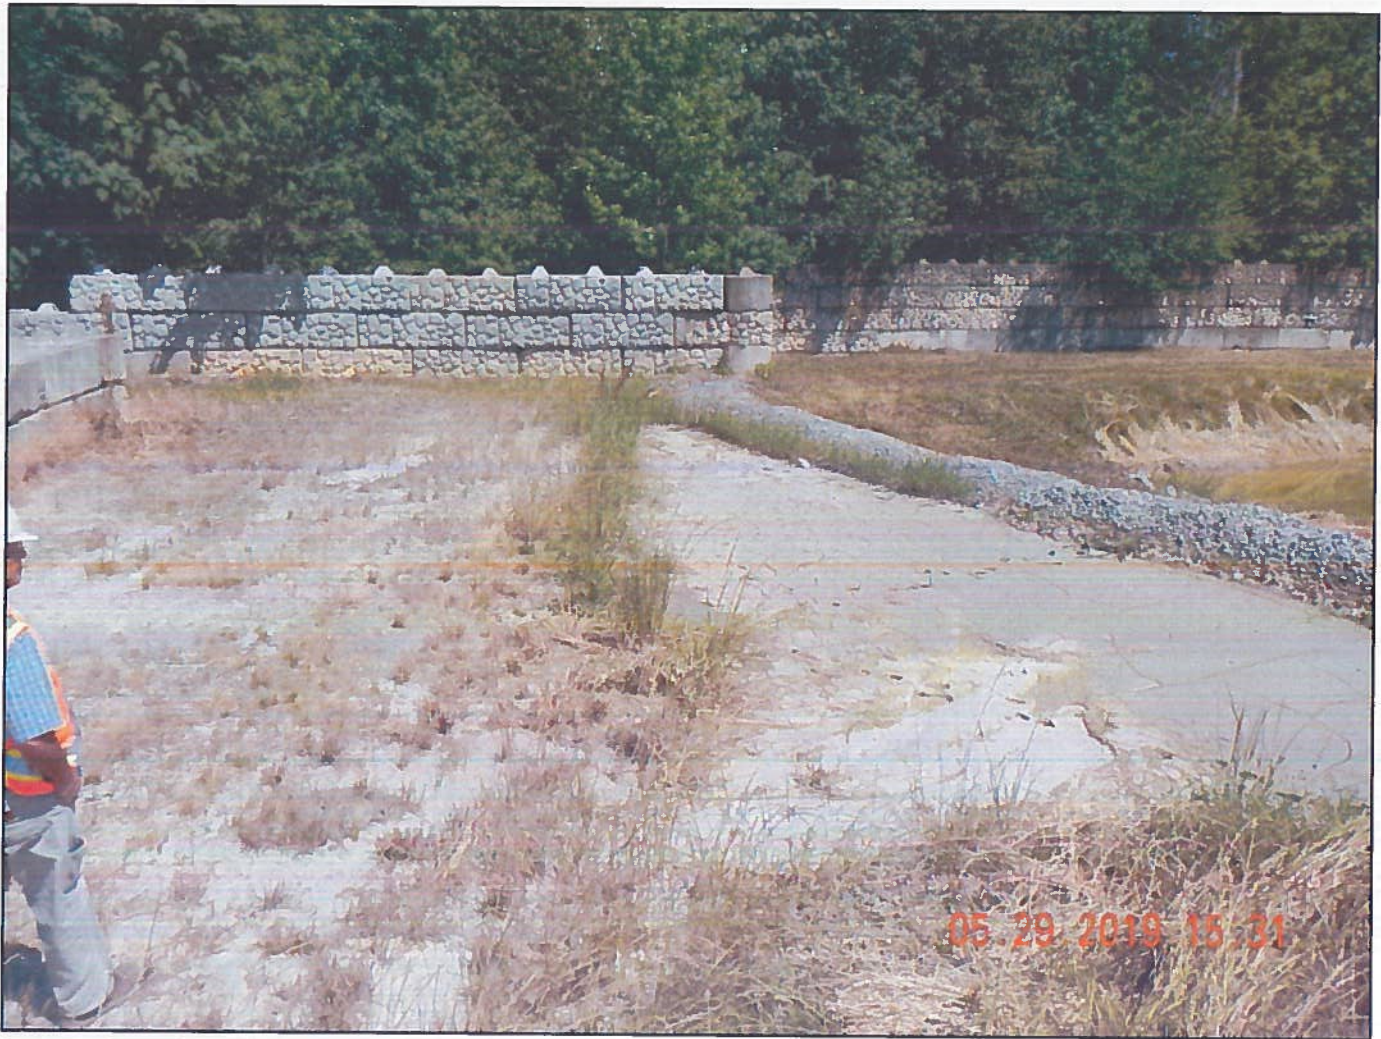
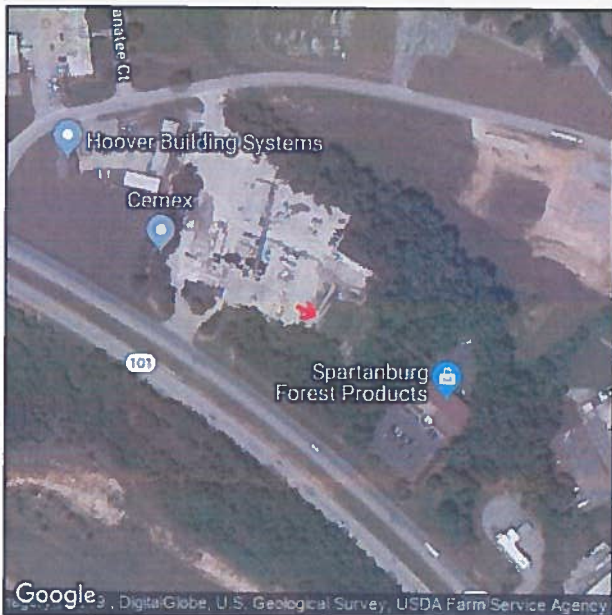
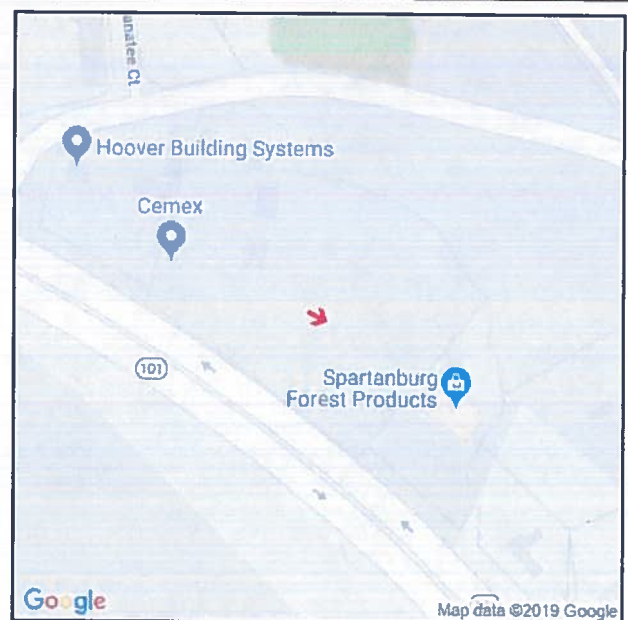
Description	Second shot of the main catch basin for runoff, near the SE corner of the site. Looking southerly. This pond area collects most of the runoff from the site, except for an area at the NNW corner.
-------------	--

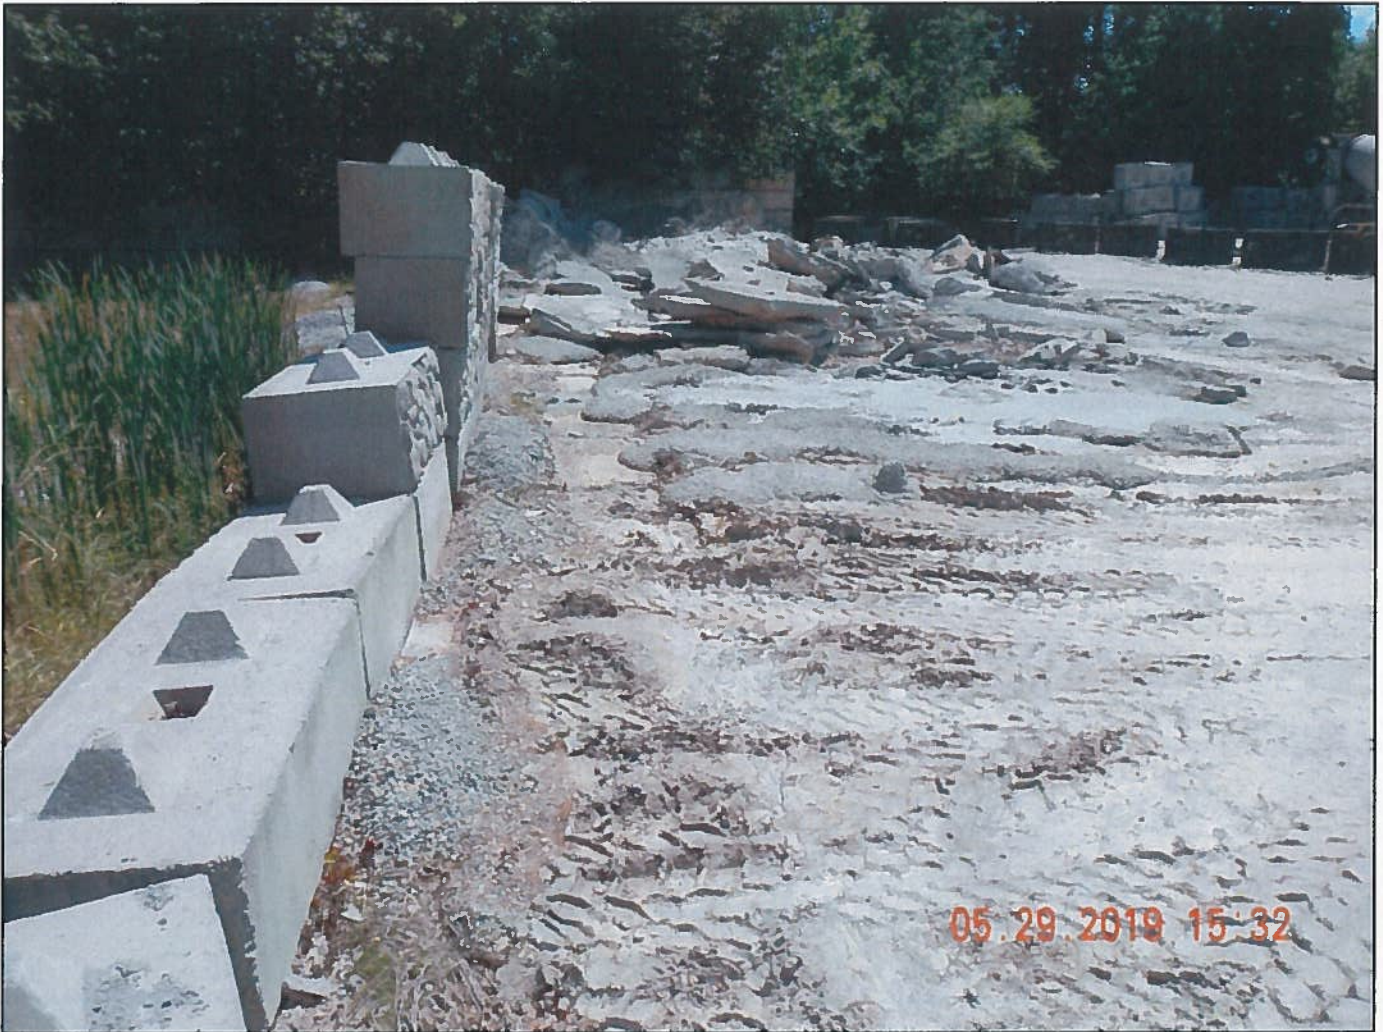
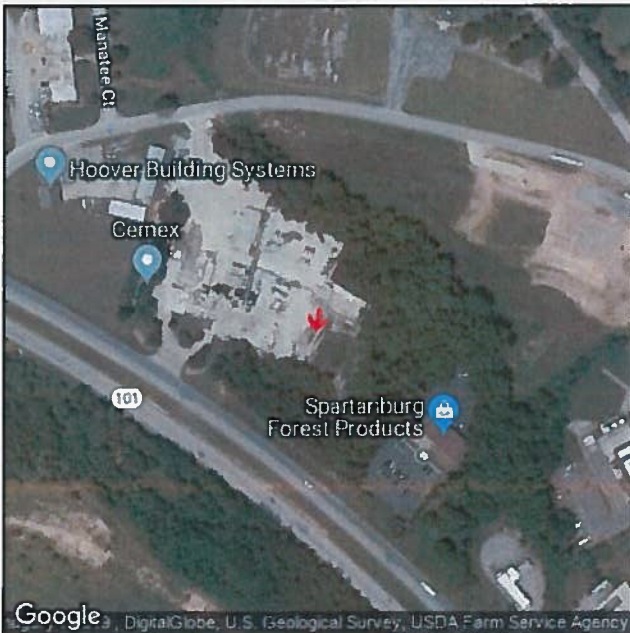
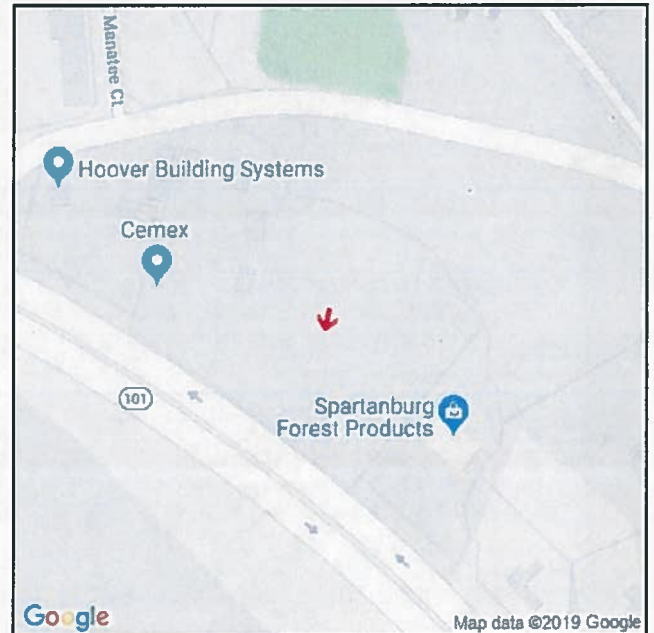
- Excess concrete not used at customer locations was discharged to the ground adjacent to and uphill from the catchment pond, providing a potential discharge of process wastewater to the stormwater collection system.
- Gray material was observed below the discharge of the pipe from the catchment pond and traced across the ground surface to stormwater drainage ditch adjacent to Highway 101.
- Concrete dust between ½ inch and 1 inch deep was observed in the paved areas of the site.
- Hay bales at outfall 002 were not in the BMPs listed within the SWPPP or on the site map. The bales were in poor condition.
- The gravel berm above the catchment pond was not in the SWPPP or on the site map.

Description	Area to the west of the stormwater collection pond for concrete rubble. Some unused fresh concrete had been wasted to this area recently. That represents a potential path for industrial/process water to exit from pour to the stormwater catch basin. In the photo, the stormwater basin is just off frame to the left (east). Looking southerly.
-------------	--

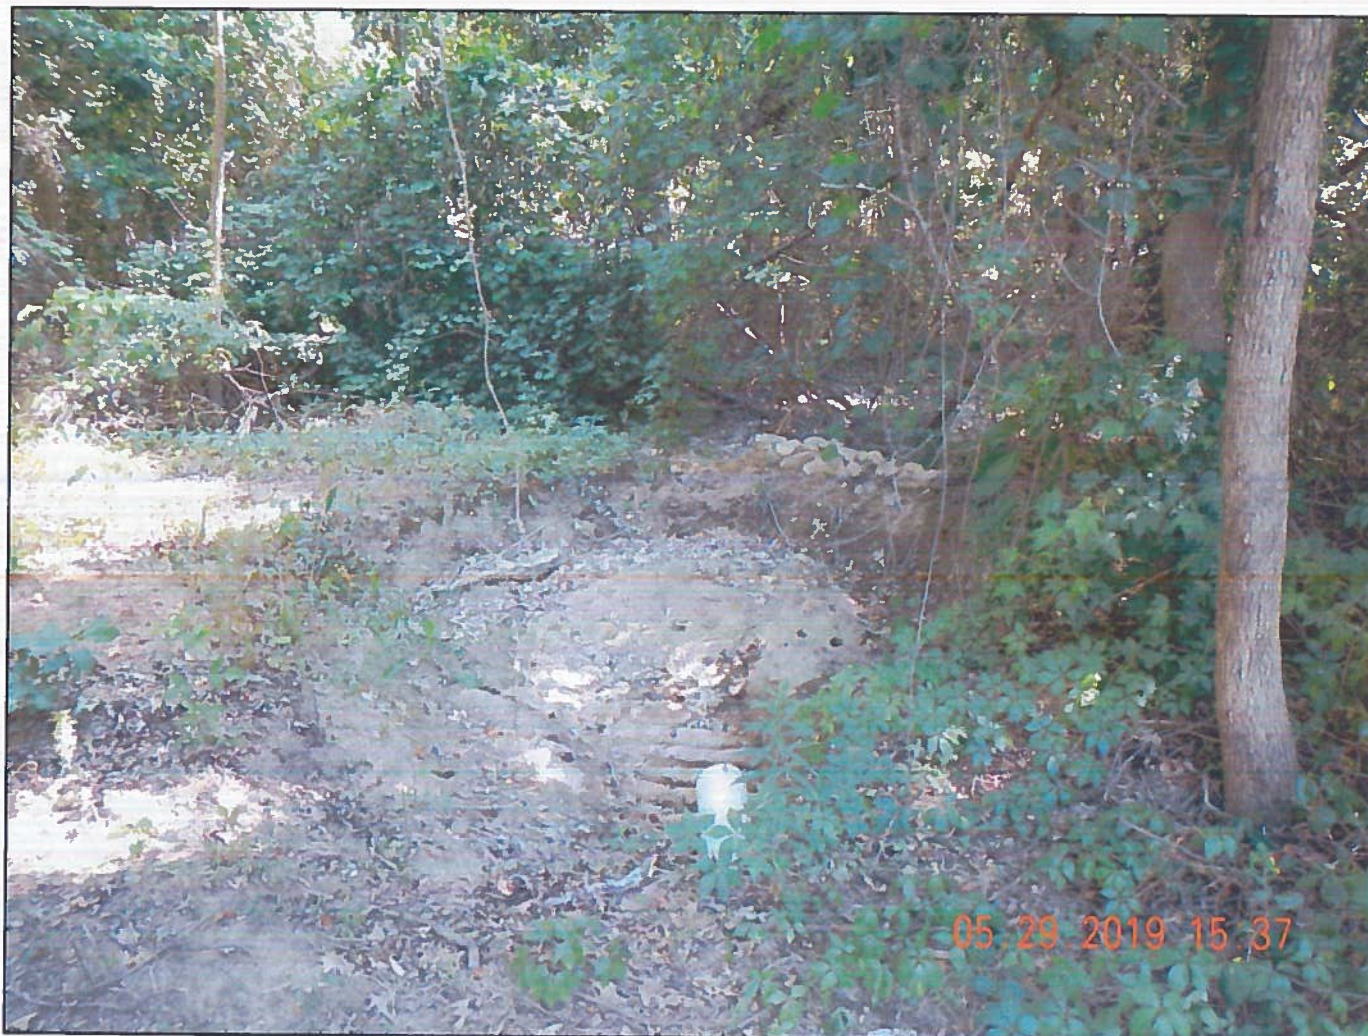
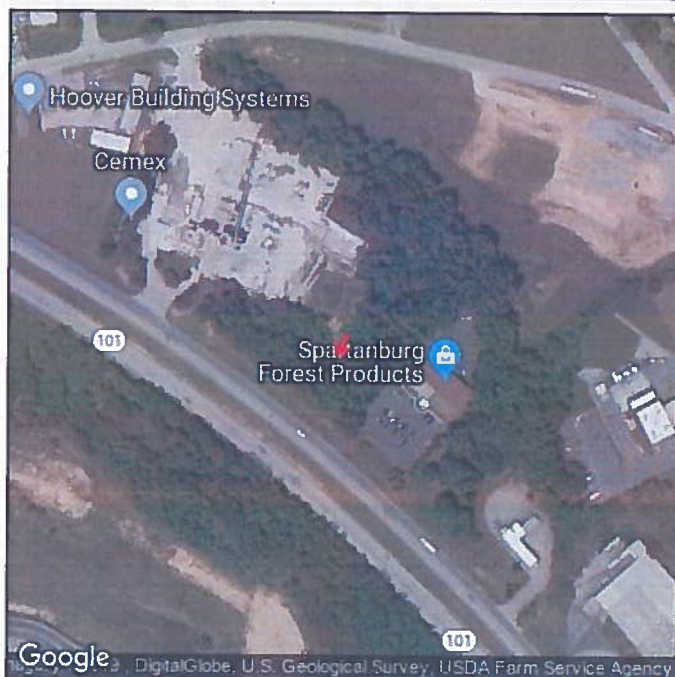
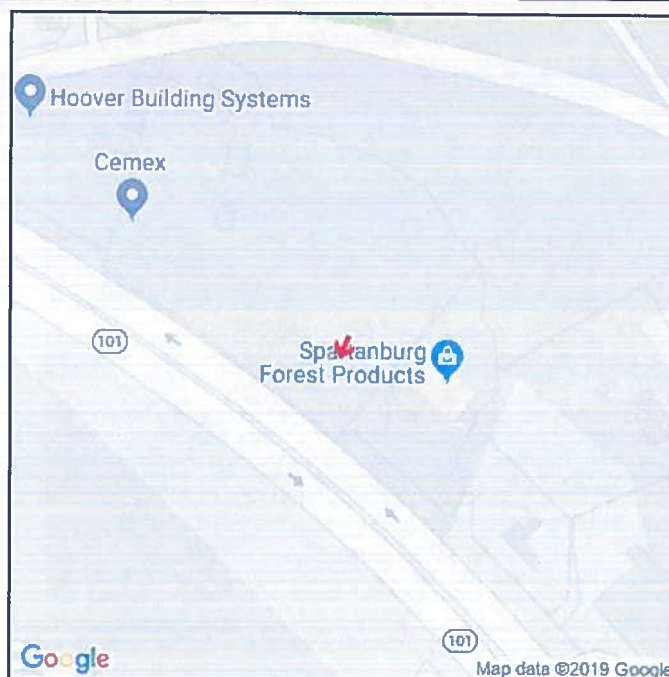
Description	Outlet structure for the stormwater collection pond. White PVC pipe exits the riser shown in DSCN1779 and discharges water here. Not visible: ditch about 20 feet beyond this (circular) discharge spot, and Highway 101 just past that. Samples are taken from this pipe when flowing.
-------------	---

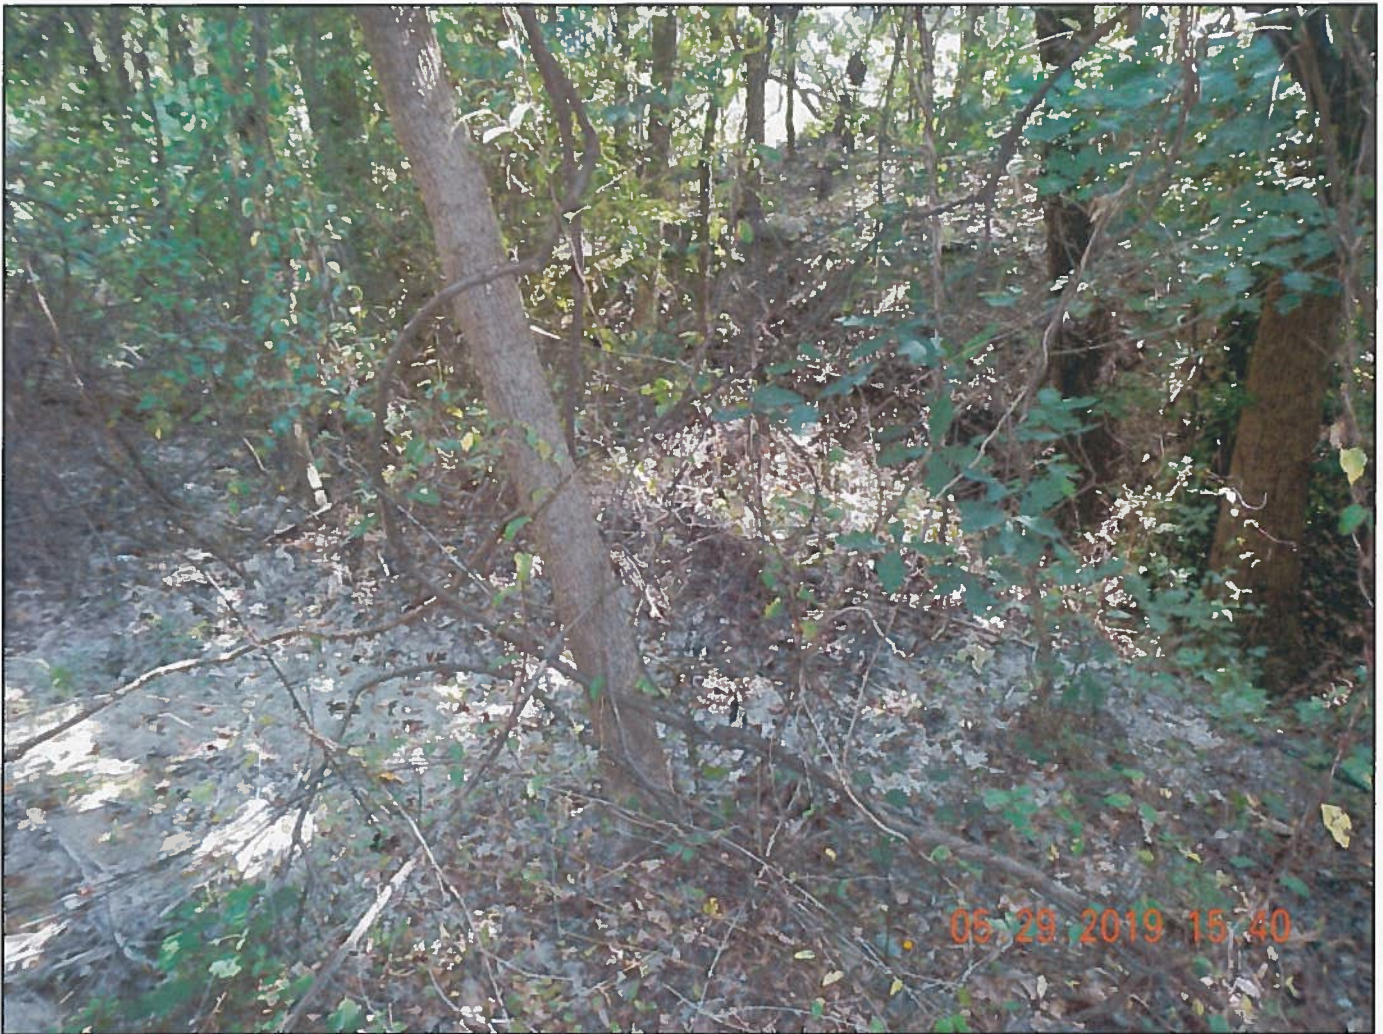
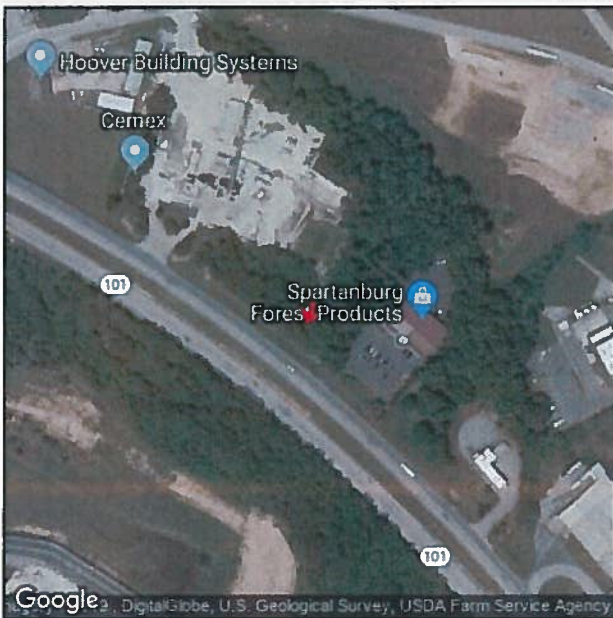
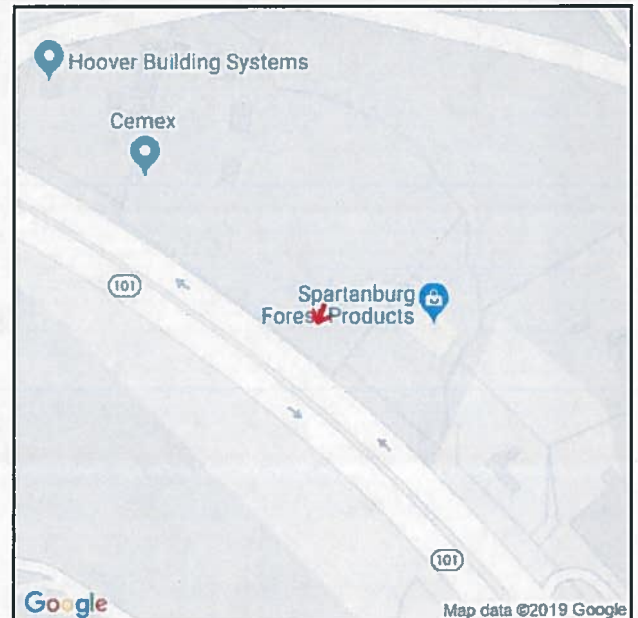
Evidence of Off-site Accumulation of Pollutants Observed in Receiving Water & MS4	Gray residue was observed below the outlet area of Outfall 001 and was traced from the outlet pipe to the stormwater ditch. See photos DSCN1782, DSCN1783, and DSCN1784.
Potential Non-stormwater Discharge Off-Site Observed	Excess concrete not used at customer locations was discharged to the ground adjacent to and uphill from the catchment pond, providing a potential discharge of process wastewater offsite. See photo DSCN1781.

Description	Flow from the outlet location seen in DSCN1782 exits the southerly end of a basin and flows across the surface through the brushy area. Looking more easterly, flow goes from left to right in this picture. Area between gray tree and two darker trees is the bottom of the ditch. Gray residue can be seen on the top of this side of the ditch (gray tree) and on the ditch bottom between the three trees.
-------------	---

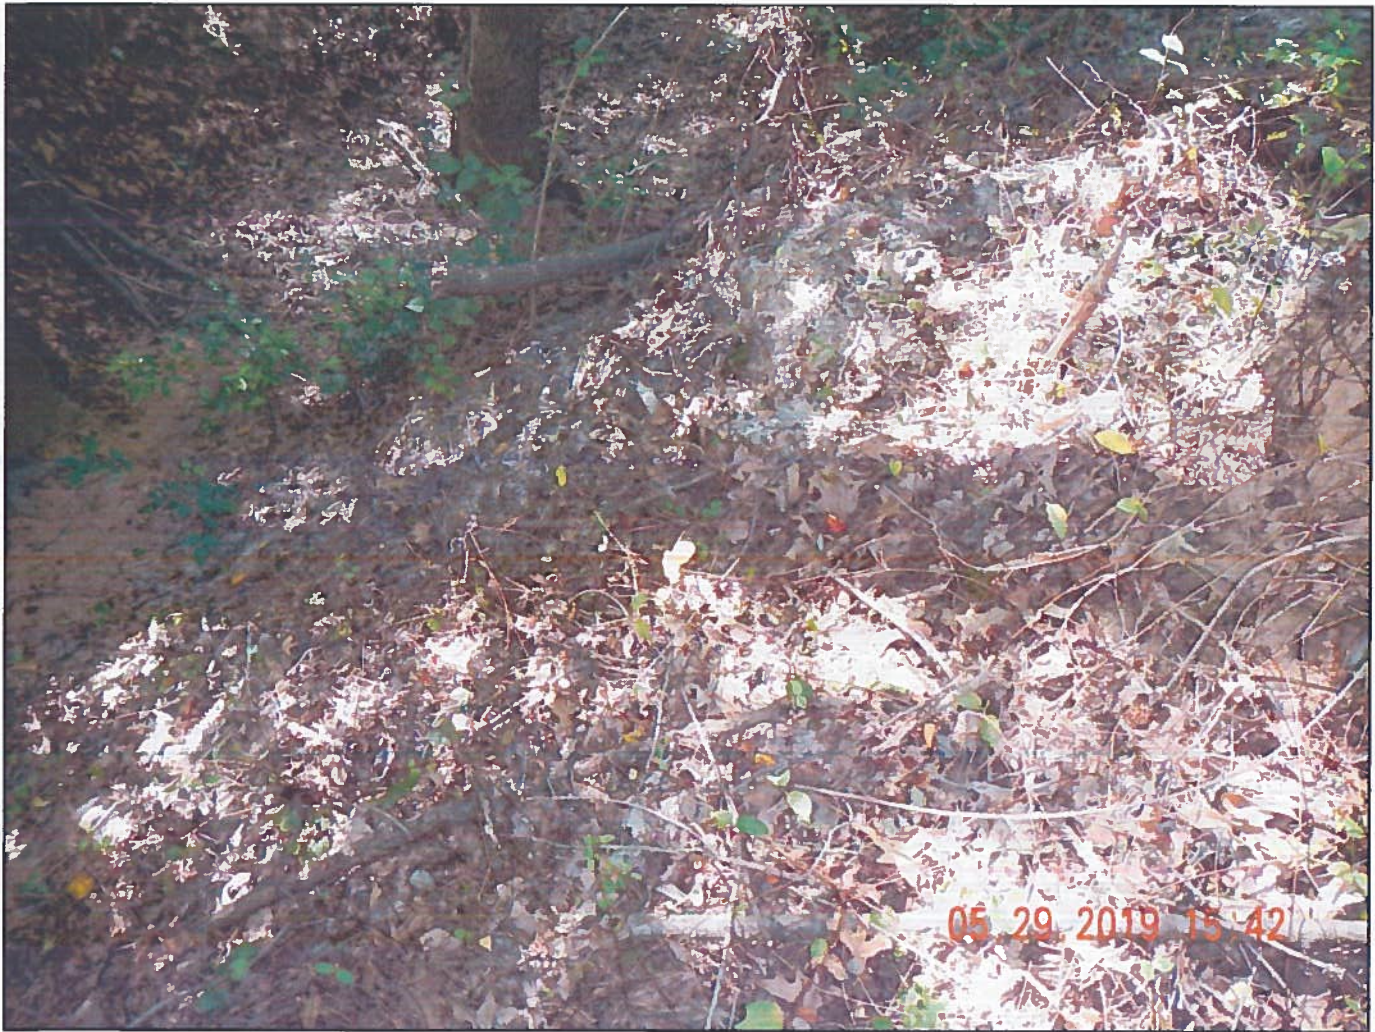
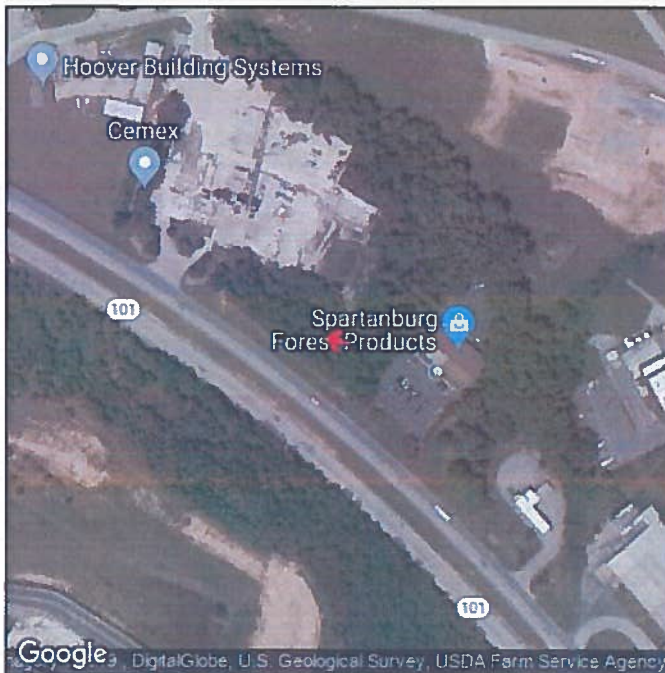
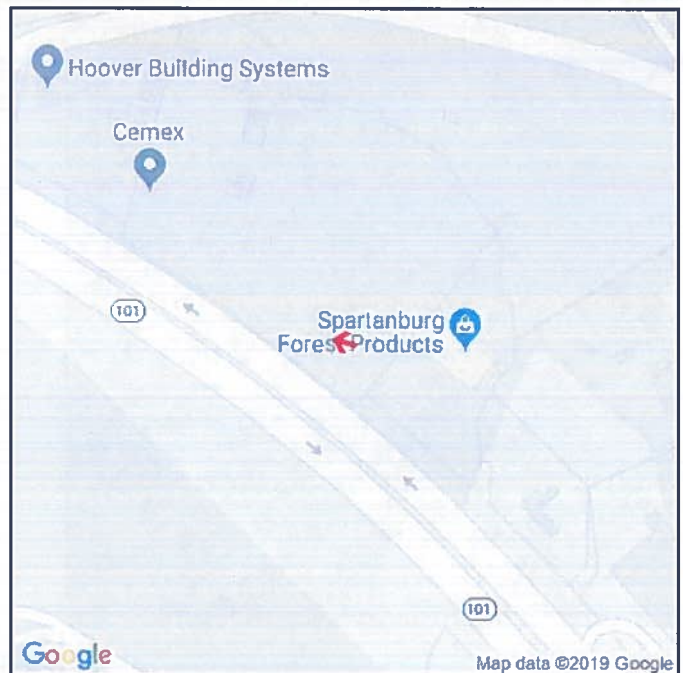
Description	View of residue on bank (center-right) and bottom (near dark tree trunk). Same general location as DSCN1783, viewing from a different angle. Flow enters ditch in this view from right to left.
-------------	---

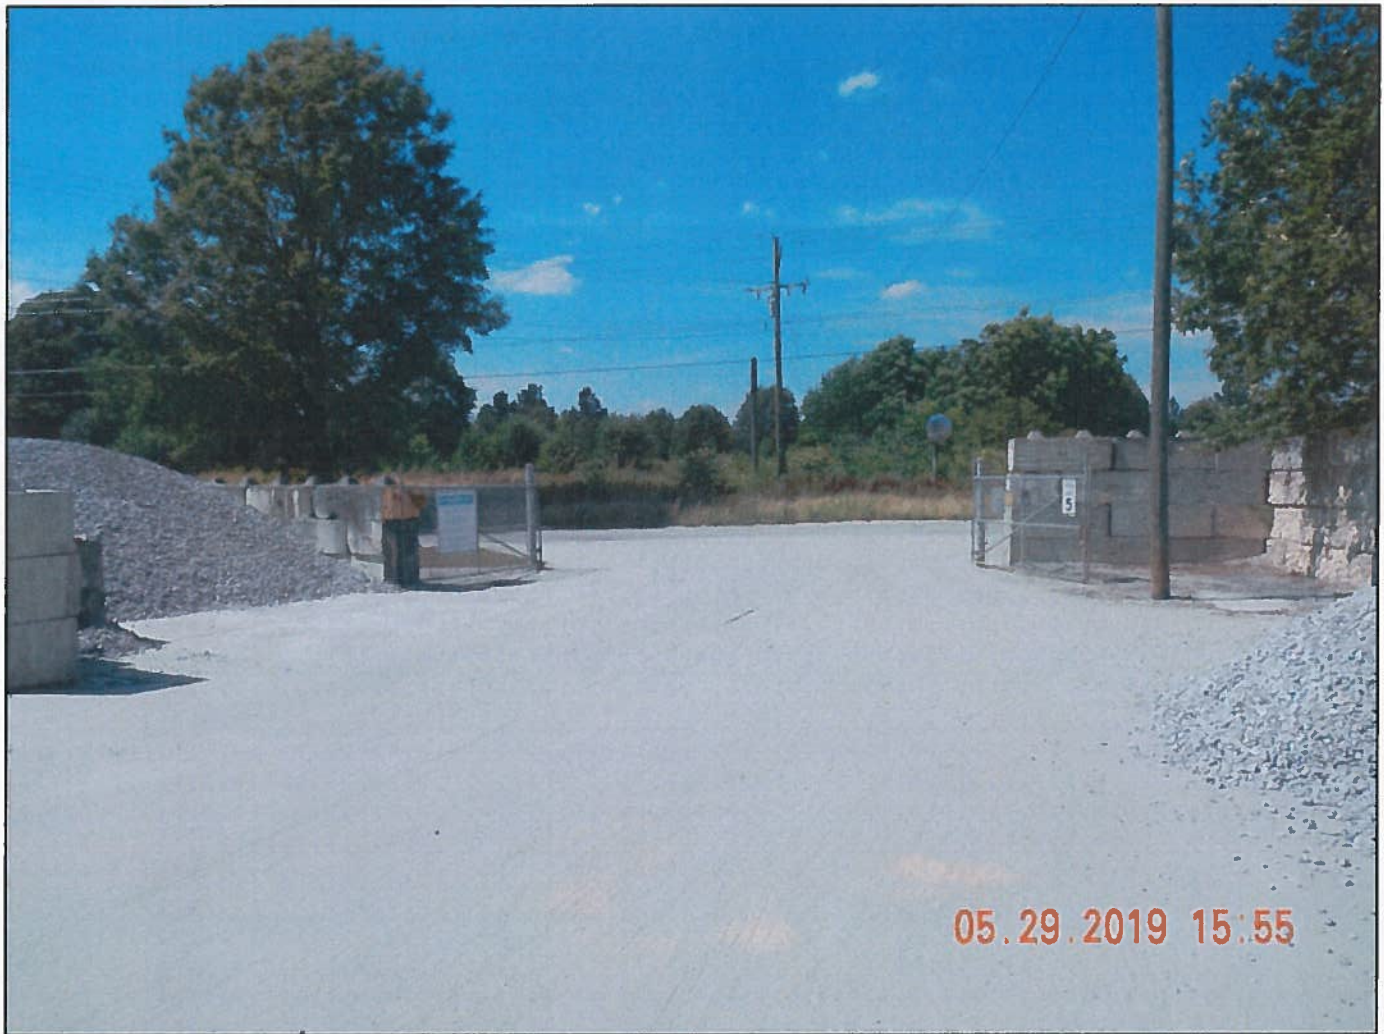
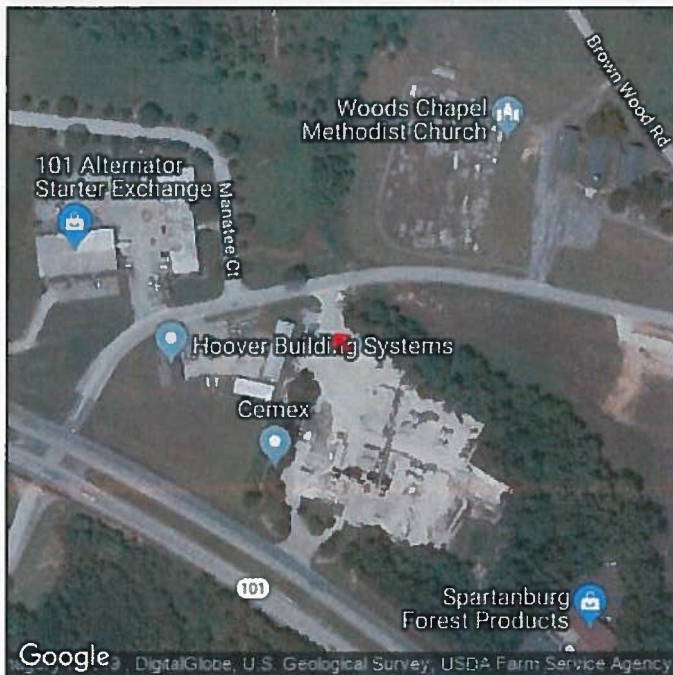
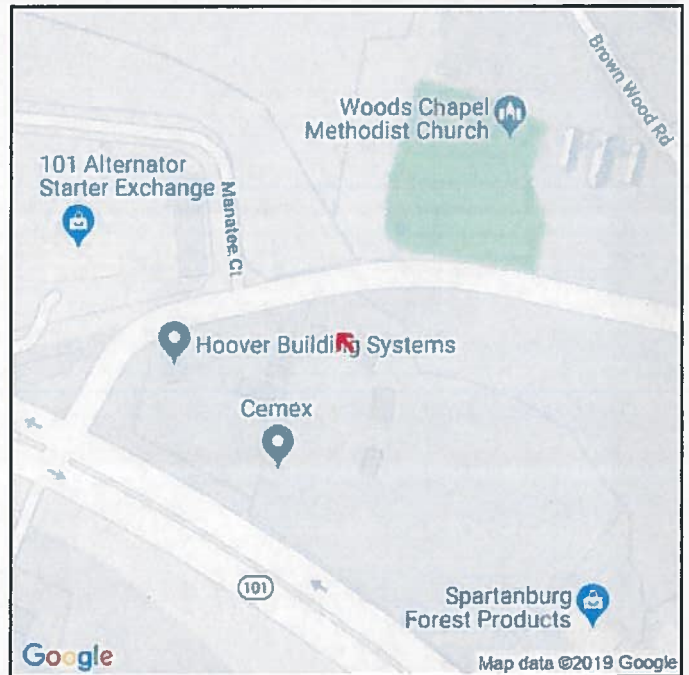
Description	View of north exit from facility, onto Old Woodruff Road. Outfall 002 is outside the gate, on the right side in this view. Looking northerly. Flow from area where photographer is standing flows out to outfall 002.
-------------	---

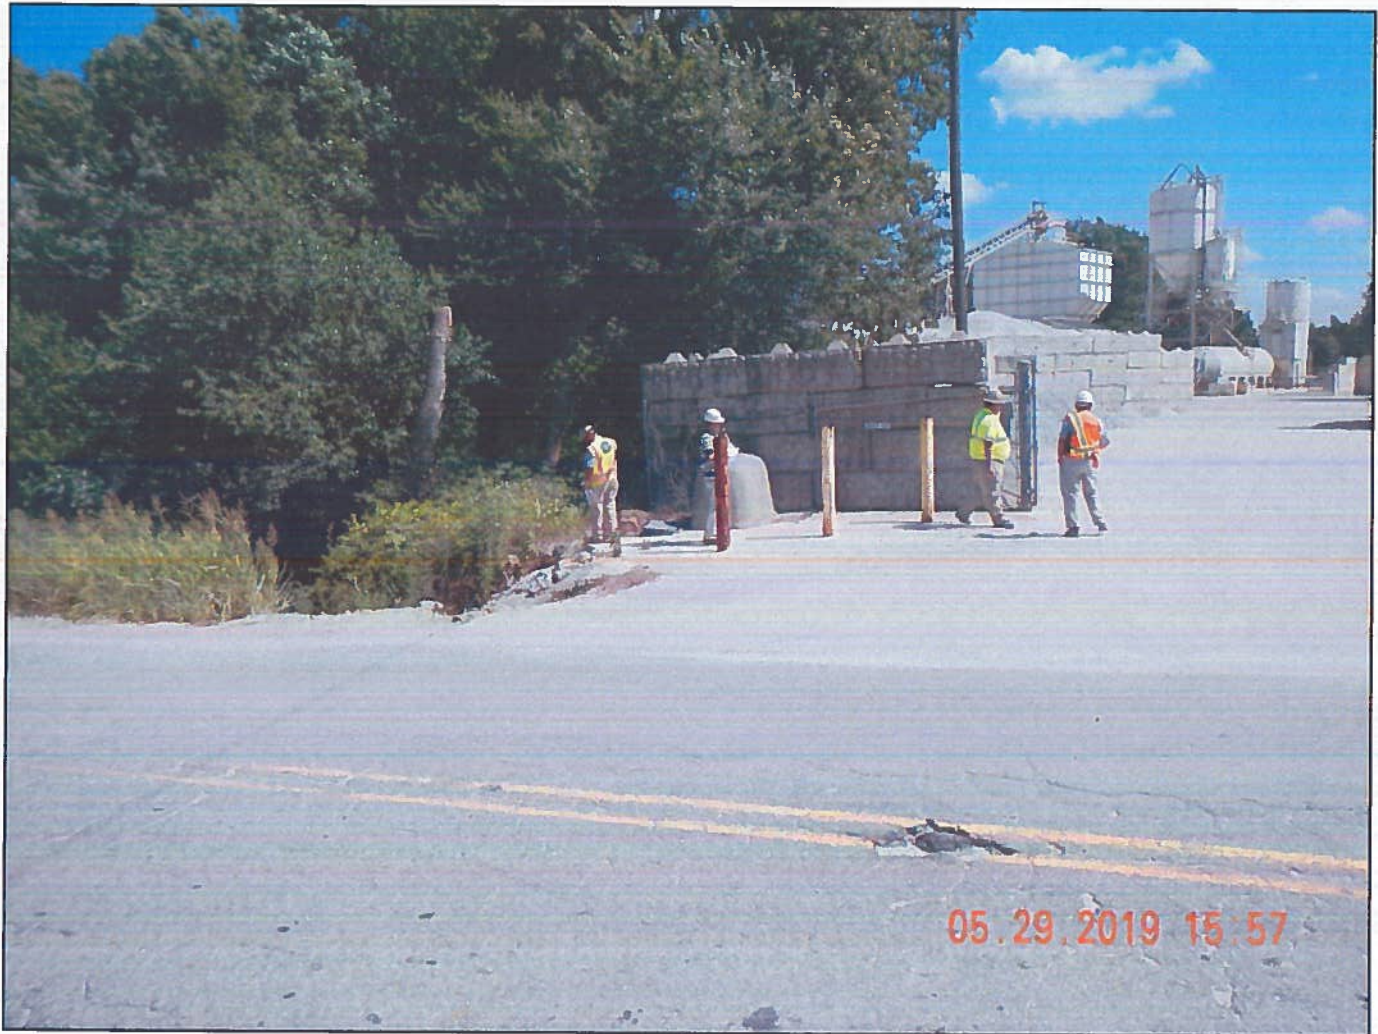
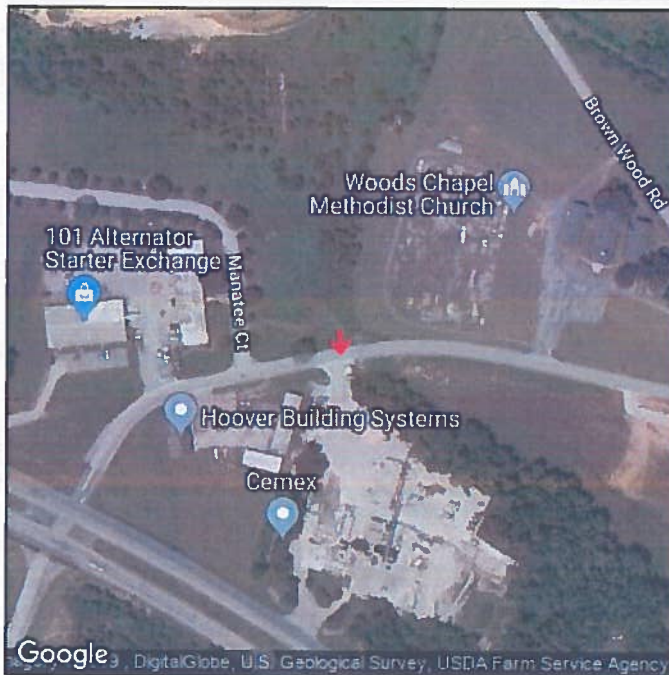
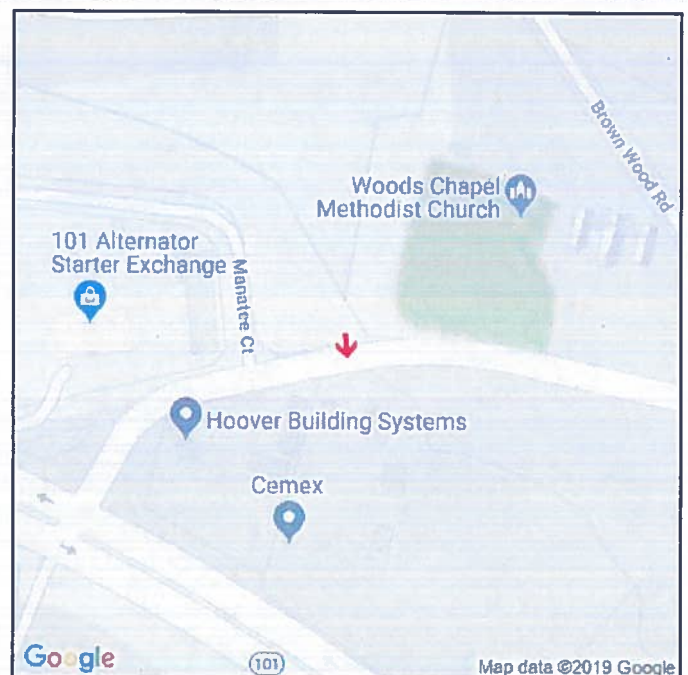
Description	Another view of outfall 002 area, looking into facility. The outfall is just to left of left-most person in photo, down the hill. Looking southerly.
-------------	--
